MEMORANDUM FOR RECORD

The following information is provided concerning a Malfunction/Accident/Incident involving TACOM equipment:

- d. Injuries/Fatalities: The Tank Commander received minor shrapnel wounds to the legs and arms and the Gunner got some in his arm.
- e. Identification of Weapon/Ammunition/Equipment/Vehicle (SN, bumper #, ammo lot #) Involved: M1A1 Tank, serial number L13170, bumper number B 24.

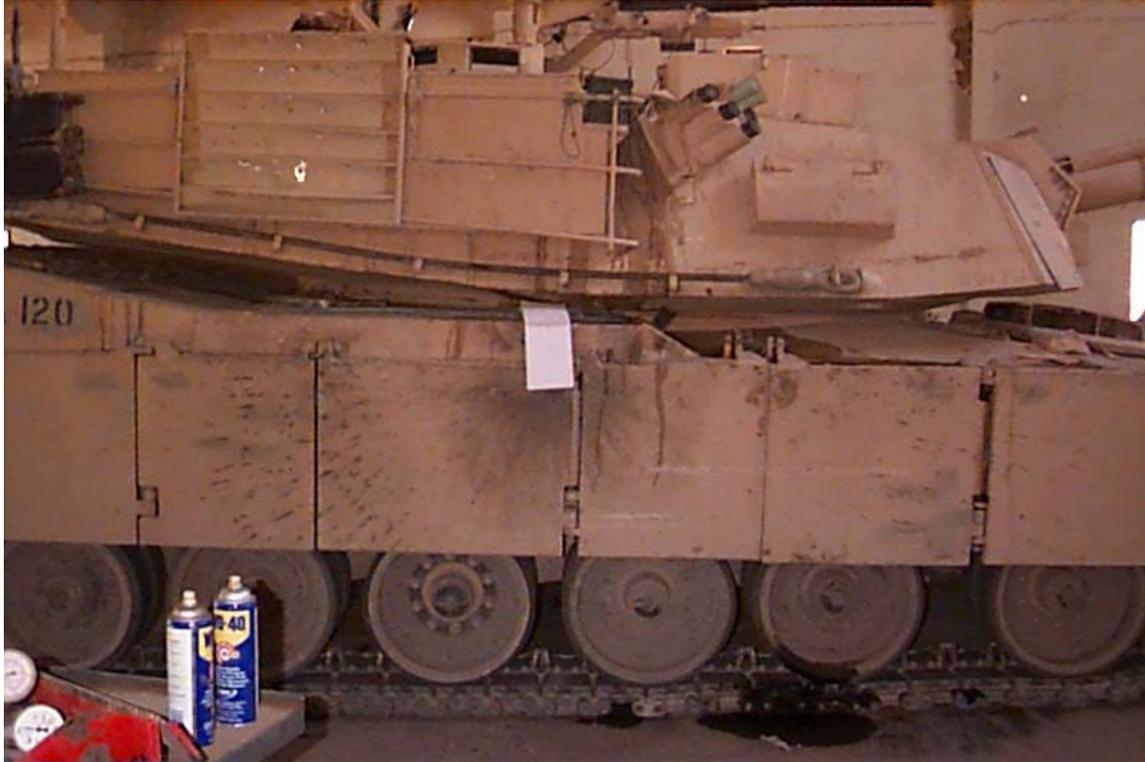
- g. Description of Incident: While on patrol the tank was hit by "something". There is a hole in the #4 Right-hand skirt. Because of the classified nature of the insides of the skirt, the hole is covered by paper in this photo:

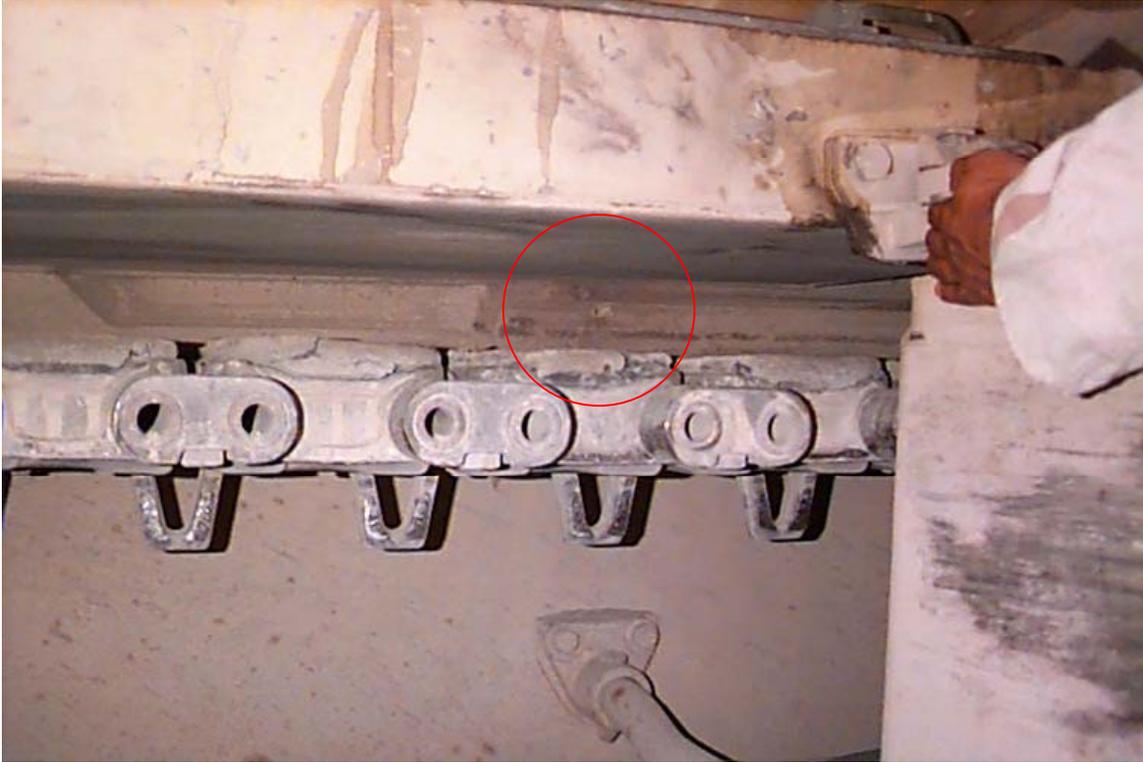
The hole is about the diameter of a pencil. My little finger will not go into it. It is in the skirt proper very near where the bead weld makes a ninety-degree turn to go up for the hinge. On the inside the skin protrudes slightly around the hole. From there the "something" traveled over the track and below the deck entering the hull with the same size hole.

The soldier is holding his hand over the exit hole in the skirt.
Here's a close-up of the hole:

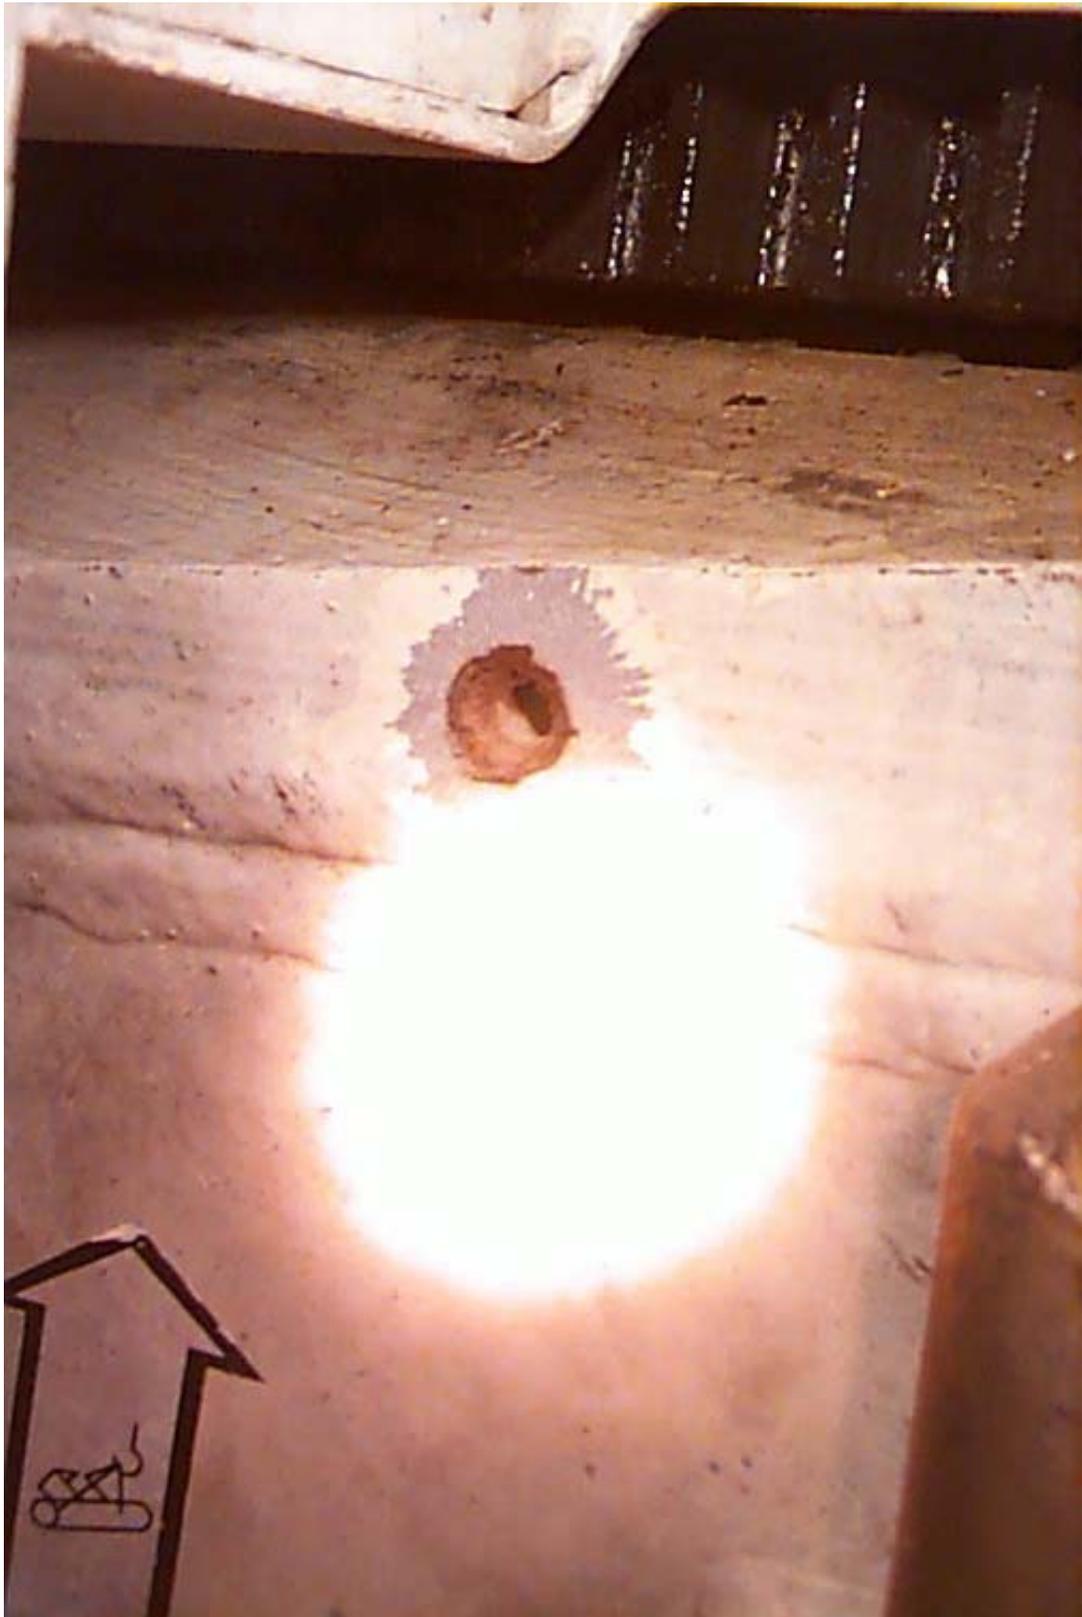
This is what it looks like on the inside where it entered the turret well:

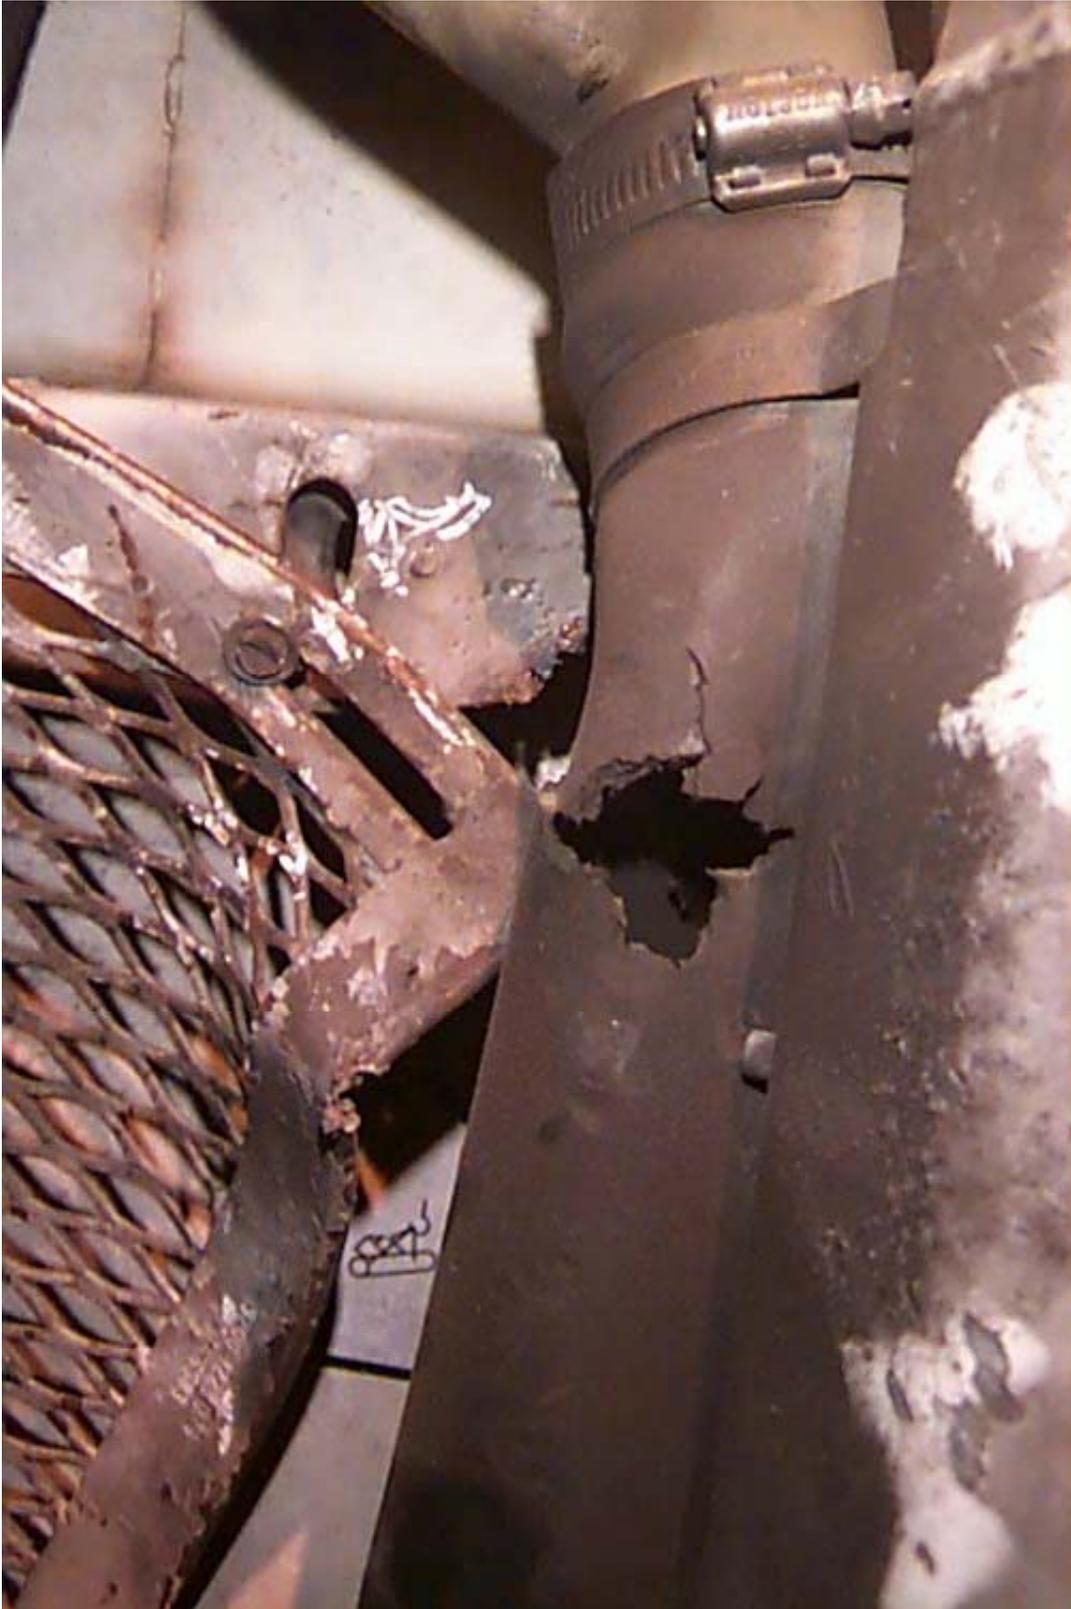
It then tore the NBC hose behind the Gunner's Seat and bent the basket shield:

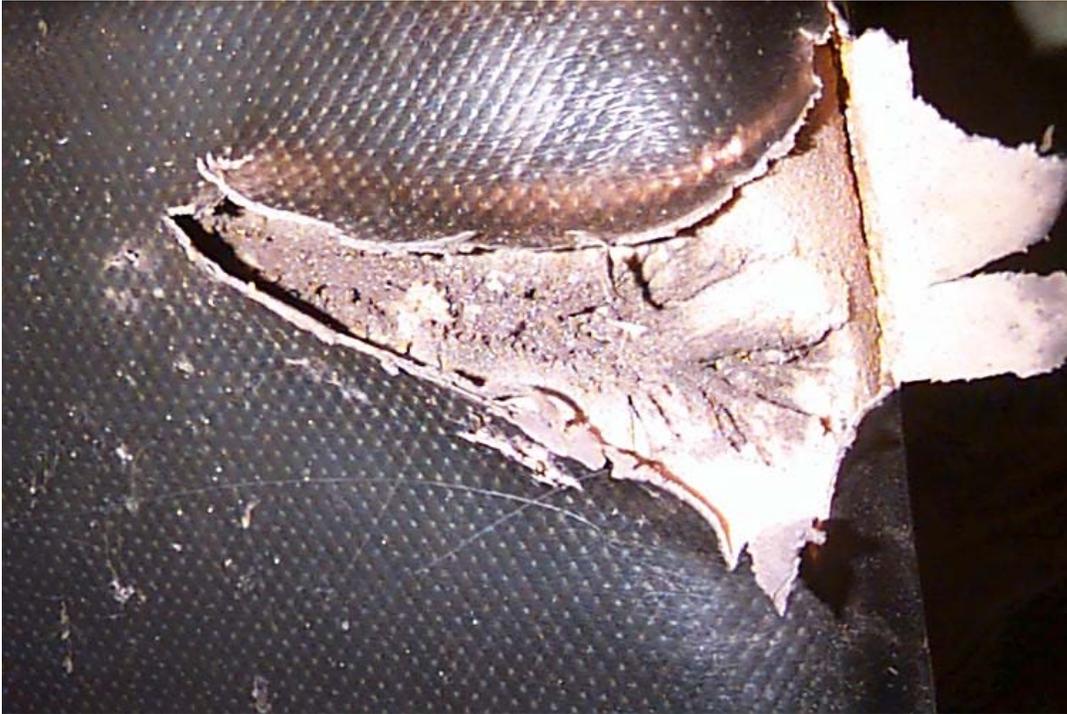
It passed through the Gunner's Seat Back at a very oblique angle.

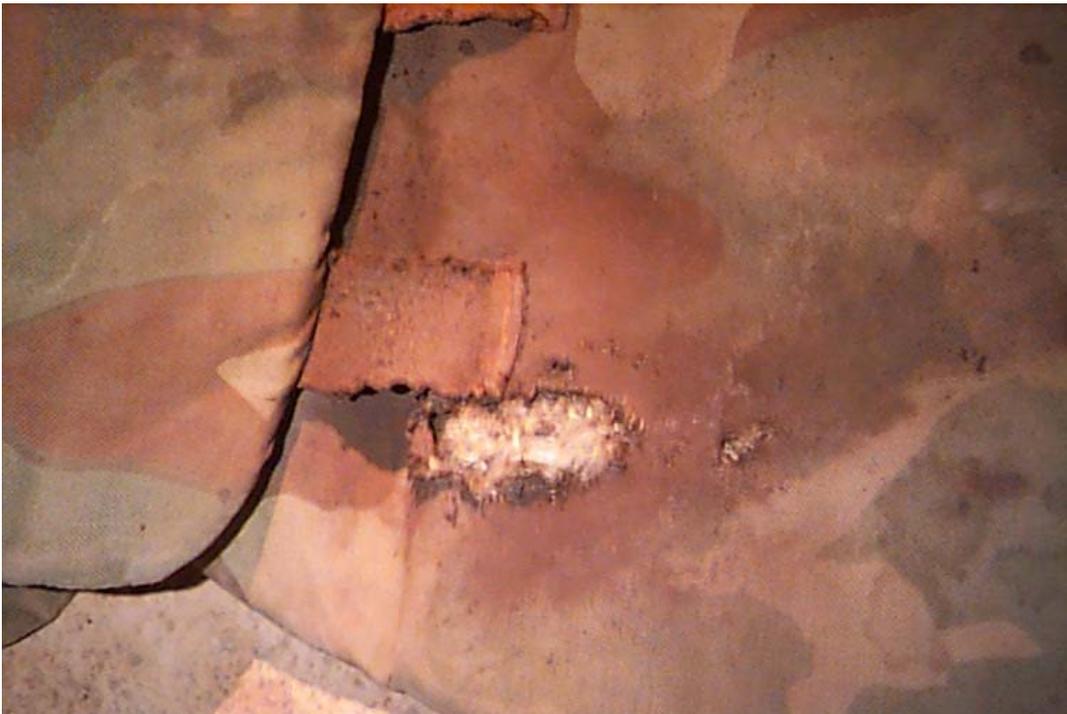
The Gunner said it felt like someone hit him in the back with a hammer and he was thrown against the GPS. Here's what the left kidney area of his flak jacket looks like:

He says he is not even bruised. The "something" then crossed under the breech and hit the safety guard. Here is the entry side:

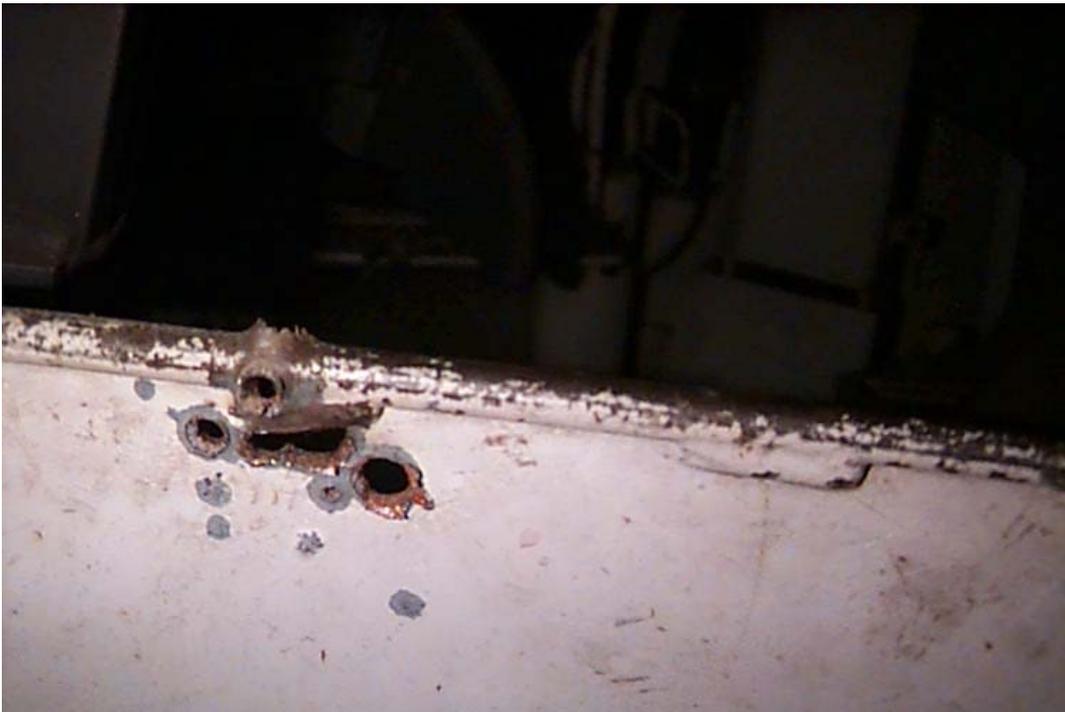
And here is the exit side, please notice the residue of what appears to be copper or bronze. This can be seen in several places:

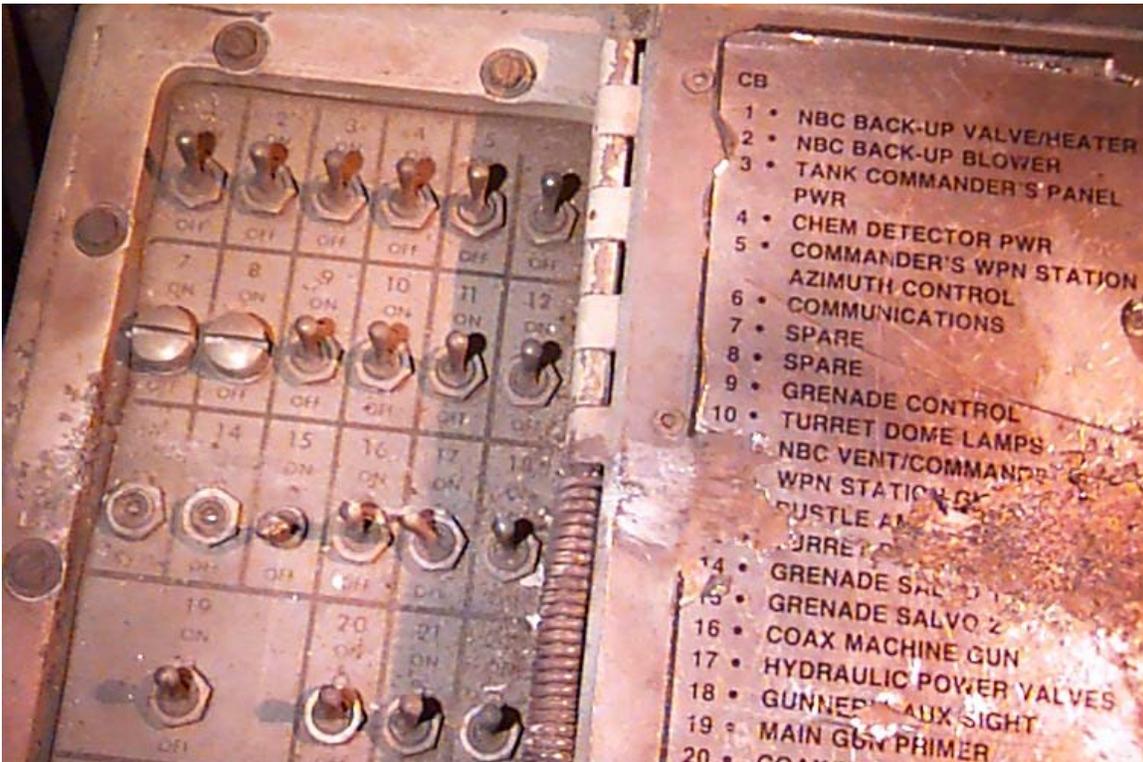
Through the Circuit Breaker Panel:

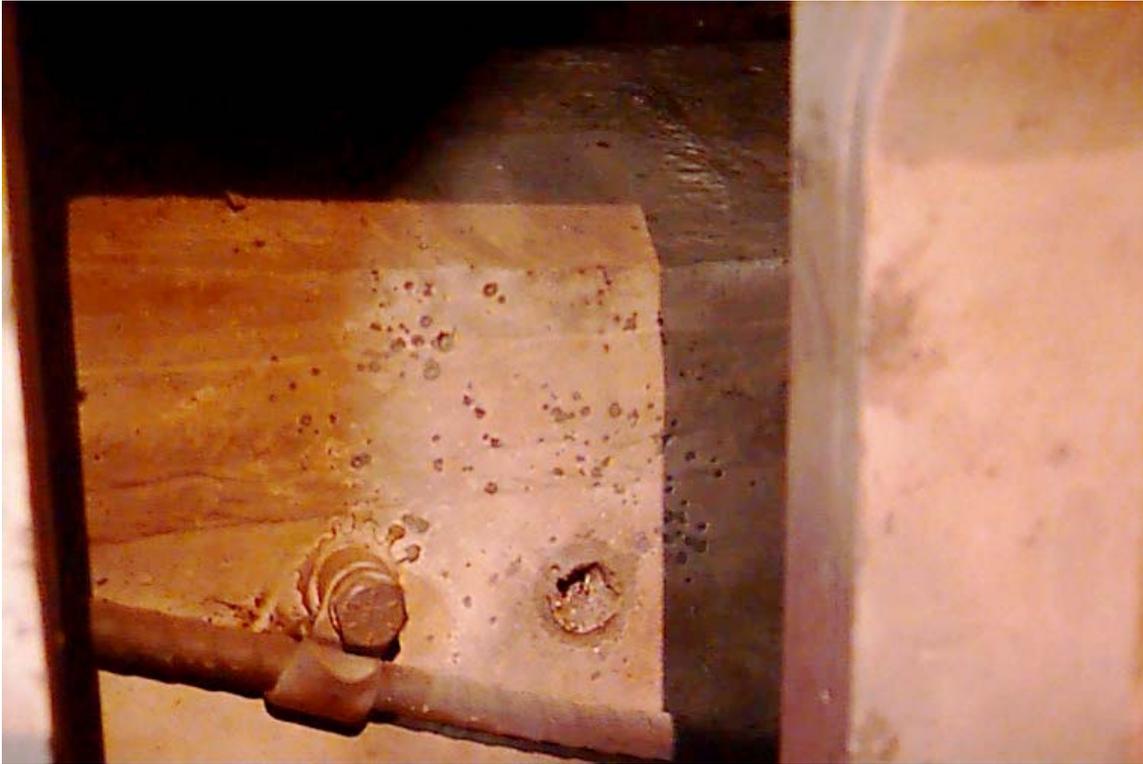
And into the hull again:

Where it dug a hole one and a half to two inches deep.
